# WATER OPERATION AND MAINTENANCE

**BULLETIN NO. 126**

DECEMBER 1983

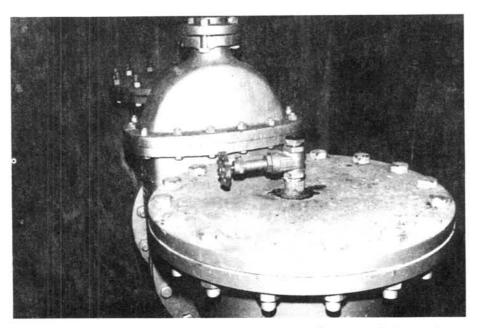
The Navajo Indian Irrigation Project in Farmington, New Mexico, was experiencing problems with plugged siphon blowoff drains. These drains frequently plug with silt and debris in spite of regularly scheduled operation of the valves to flush out the material. The method used to clear the plugged blowoffs was by "slugging" with a high flow of water. This method did not always work well and was not feasible if an emergency required unwatering a siphon during the nonirrigation season. The other alternative for removal of blockage is to pump the siphon down through the transition and manually remove the plug. This method was a slow process and expensive.

Figure 1.—View of coupling, valve, and pressure hose fitting installed on siphon blowoff to permit use of air pressure to clear obstructions from the discharge pipe.

Mr. Leroy Frame has developed a new method for clearing obstructions from these siphon blowoff drains. He used 1-in (25-mm) diameter pipe nipple, ball valve, and air hose connection (fig. 2 on following page) and welded them to the blind flange at the top of the riser pipe immediately upstream from the discharge valve (fig. 1). The cost of this addition is approximately \$15. A 150-ft³/s (4250-L/s) air compressor is then used to pump air into the plugged riser pipe until the obstruction is forced back into the siphon, freeing the blowoff piping for use. The amount of air pressure applied to the riser pipe should not exceed the rated pressure of the blowoff piping and valve.

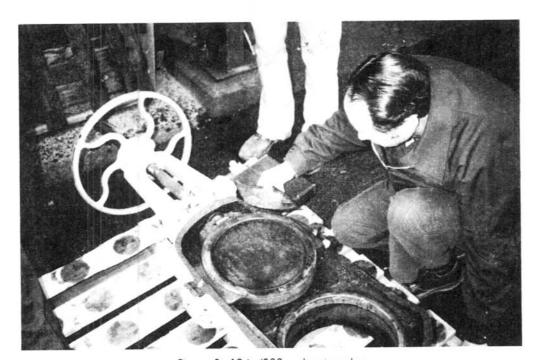
Figure 5.-12-in (300-mm) gate valve.

The 12-in (300-mm) gate valve that failed was a Crane 200 water, oil, and gas, flanged, cast iron valve rated for 200 lb/in² gage (1380 kPa) working pressure, nonshock, and shell tested to 350 lb/in² gage (2413 kPa). The maximum pressure this valve experienced during its life was 105 lb/in² gage (725 kPa) static. The raw edge along the fracture line appears to have failed as a brittle fracture, typical of cast iron.

The failure of the 12-in (300-mm) gate valve appears to have been a brittle failure, possibly caused by a material defect. More probably, however, the failure was the result of a combination of fatigue and embrittlement due to crystallization of the metal. The valve had experienced dynamic oscillating loads since about 1962 as a result of the nozzle discharge forces situated 10 ft (3 m) away.

It is recommended that the valve be inspected and tested by an experienced metallurgical and nondestructive testing laboratory to determine, if possible, the cause of failure. The replacement valve should be a cast steel valve 125 lb/in²gage (860 kPa) steam rated and not cast iron. A coupling placed between the valve and the discharge nozzle is recommended to soften dynamic loads and to relieve thermal and static shocks. A report on the causes of the valve failure should be issued and an investigation into other potentially hazardous sites Bureau-wide should be initiated.

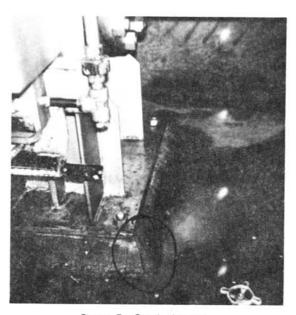
Figure 7.-Cracked grout.

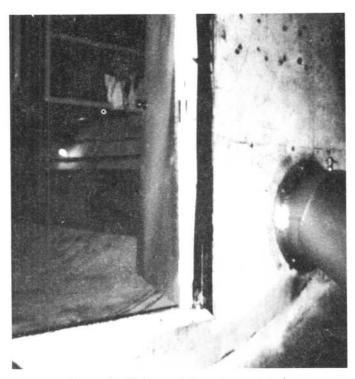
Damage to the outlet works structure was minimal. The steel door opening to the tunnel was destroyed including its jamb. The tunnel sump pump and motor ran under water for some time, but only required cleaning and general maintenance. The 10-in (250-mm) jet flow valve and discharge nozzle was moved downstream about 1/4 in (6 mm), cracking the grout under the valve support. It is assumed that both the gate valve and the jet flow valve were alined and grouted during installation, thus preventing the presence of residual stresses within either valve. The nature of the gate valve failure prevents verification of this assumption.

Figure 8.—Collapsed door to penstock tunnel.

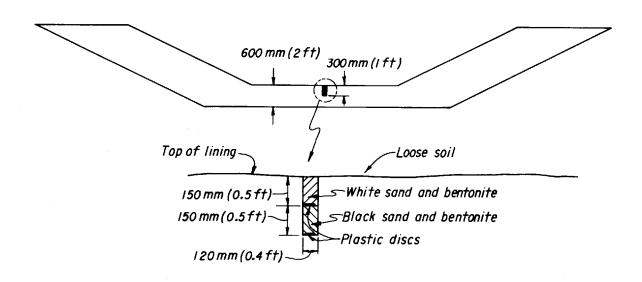
We have started to collect ideas on reference points from people at the E&R (Engineering and Research) Center. One possible method of establishing reference points is illustrated on figure 9. This would consist of an auger hole filled with sand with a distinctly different color than that of the soil lining and containing markers at known depths. Enough clay (bentonite) would be added to make the sand impervious. These could be installed at each 100-ft (30.5-m) station. Possibly a colorful plastic tape of the type used by utility companies for locating underground facilities could be used to help locate the auger holes.

Figure 9.—One method of establishing reference points.

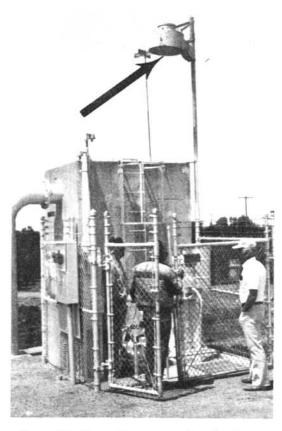
Vandalism has been a recurring problem at a pumping plant operated and maintained by the Exeter Irrigation District in California. Light bulbs have been shot out repeatedly. However, the District has reported that use of the bulletproofing material "Lexan" has been successful in protecting key components at the plant (see figure 12).

Figure 12.—"Lexan" cover on plant illuminator (arrow) has been successful against vandals.

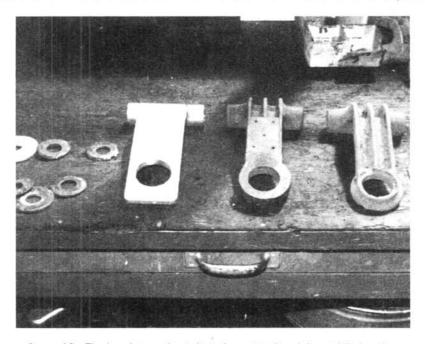
Consolidated Irrigation District No. 19, that operates the Spokane Valley Project in Washington, has been experiencing problems with the flappers in the check valves at pump sites. They solved the problem by replacing the hinged bracket that holds the flapper plate with an aluminum bracket with brass and teflon bushings. This new bracket is less expensive to produce and easier to maintain (fig. 13). The district is planning to replace all the old brackets with the aluminum model over a 3-year period.

Figure 13.—The bracket on the right is the original and the middle bracket has been rebuilt from the original. The bracket on the left is the aluminum model with brass and teflon bushings.

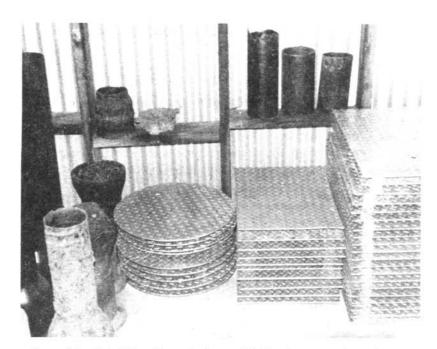
The district is also phasing out their use of concrete lids on their delivery boxes. The concrete lids are deteriorating from freeze-thaw action and are being replaced with the metal lids shown in figure 14. The lids have angle iron welded to the bottom to keep them in place and a hole drilled for lifting (hooking) convenience.

Figure 14.—Metal lids with angle iron welded to bottom to keep them in place.
